# Inspection Report

**Property Address:**  
Sample Ave.  
Marquette MI 49855

**Hiawatha Home Inspections**

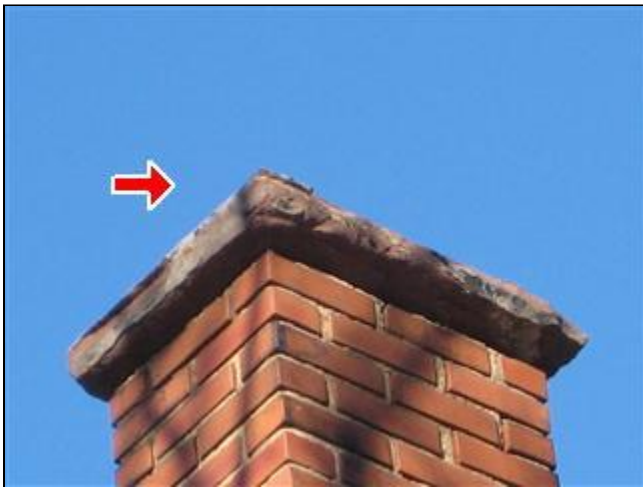
1.2 Picture 1

1.2 (1) The chimney cap is in need of repair. Further deterioration could allow water to seep into chimney and shorten it's life.

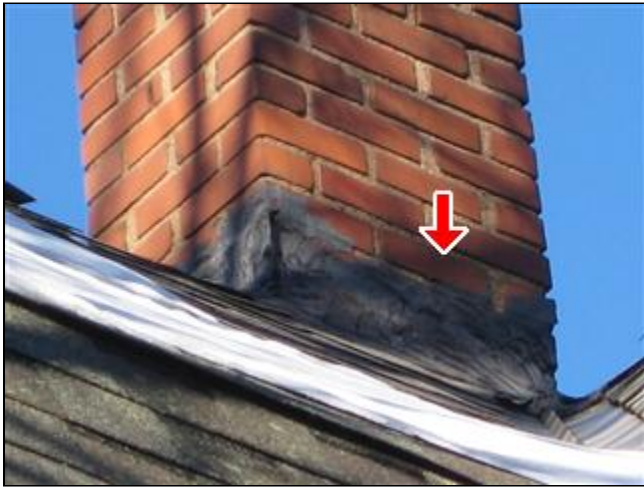
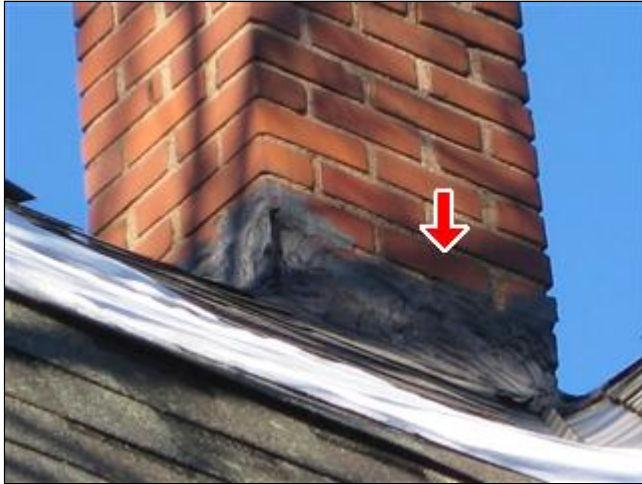
1.2 Picture 2

(2) A repair was made to the chimney flashing. While flashing was visible from the bottom, I could not determine if proper step flashing and counter flashing were present. Minor signs of previous moisture intrusion were visible on the chimney brick in the attic. I recommend monitoring the chimney in the attic for moisture in the future.

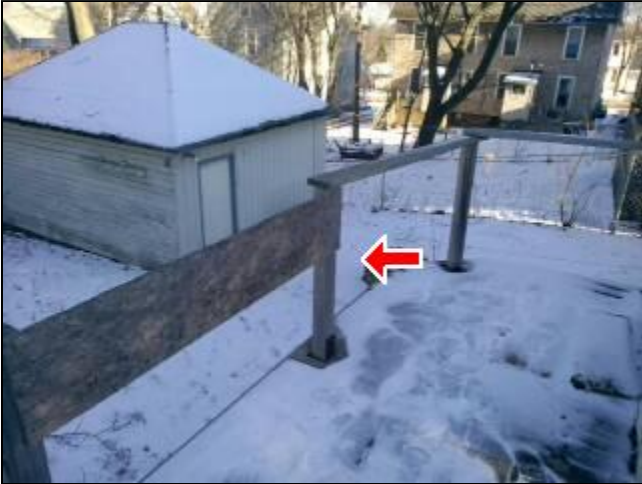
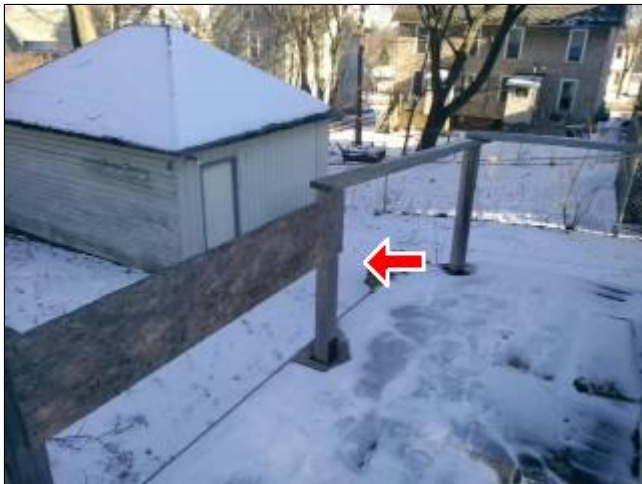
2.3 Picture 1

**2.3** The guarding for the rear porch is spaced too far apart for safety and the guarding and handrail material is inadequate. This should be repaired by a qualified contractor.

The guarding for the rear porch is spaced too far apart for safety and the guarding and handrail material is inadequate. This should be repaired by a qualified contractor.

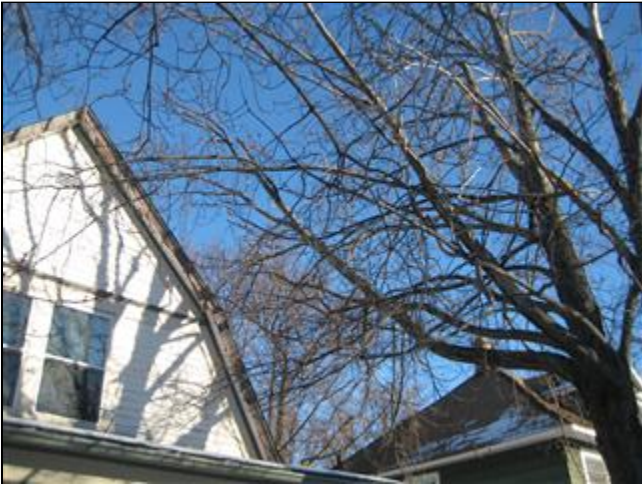
2.4 Picture 1

**2.4** Recommend trimming this tree branch to prevent damage to the roof and siding.

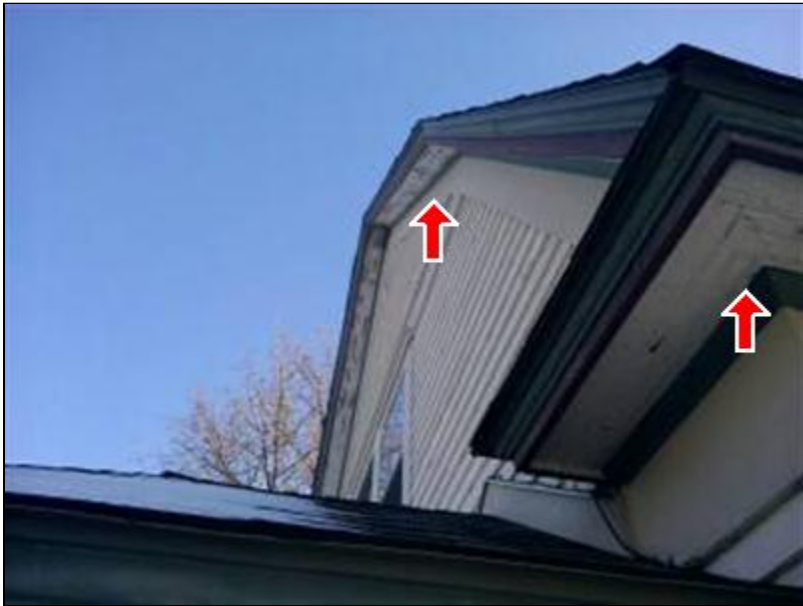
2.5 Picture 1

**2.5** The paint on several soffits and fascia is failing. I recommend prepping and painting these areas.

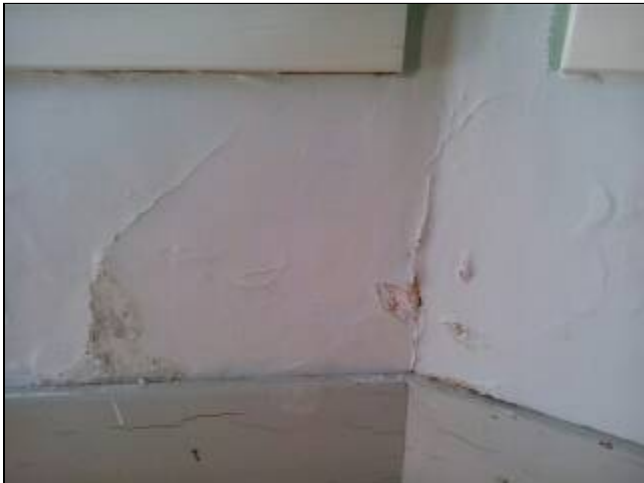
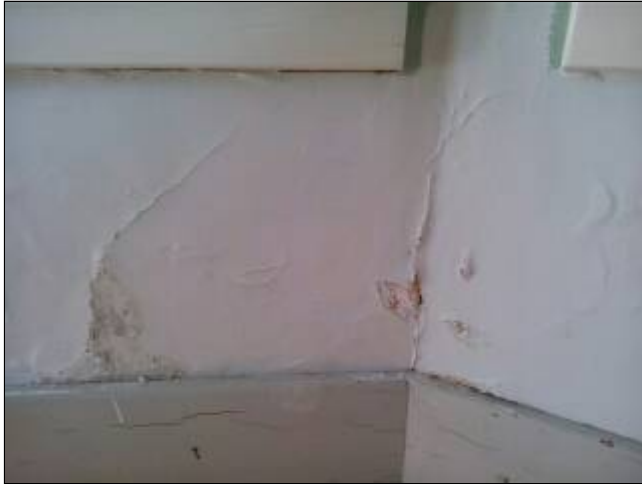
3.1 Picture 1

**3.1 (1)** The plaster on the wall shows wet stains indicating moisture intrusion did or still may occur at the Dining Room. The moisture meter was used and it did not indicate an active leak. A qualified contractor should repair or replace as needed.

(1) The plaster on the wall shows wet stains indicating moisture intrusion did or still may occur at the Dining Room. The moisture meter was used and it did not indicate an active leak. A qualified contractor should repair or replace as needed.

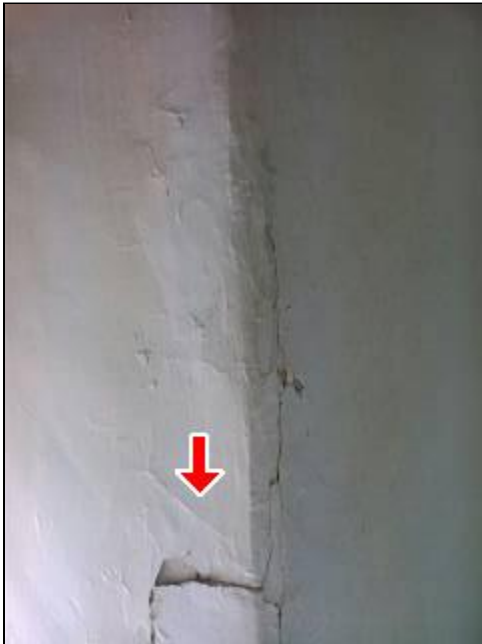
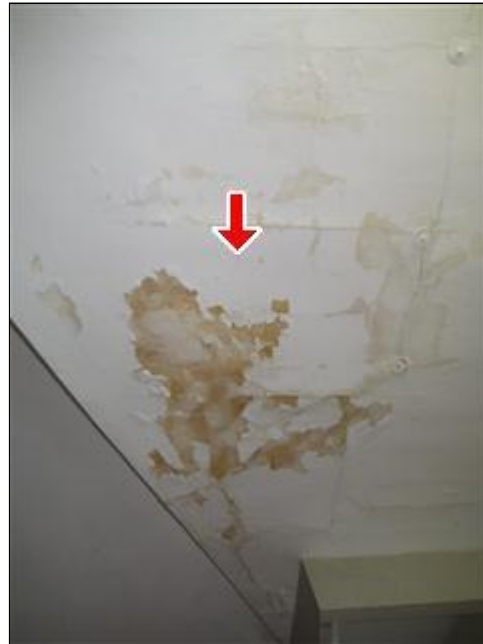
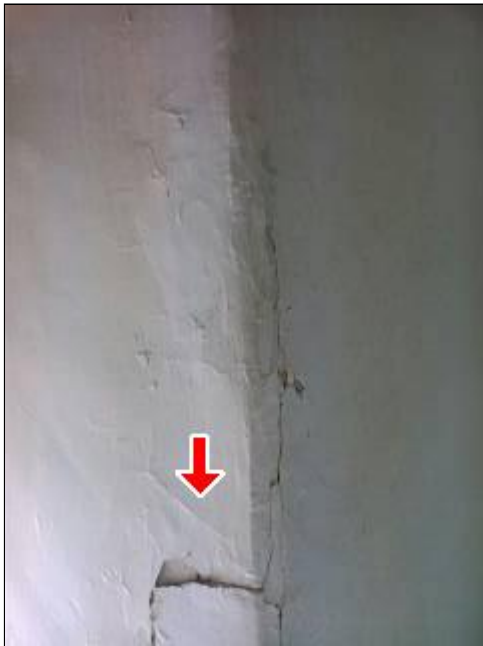
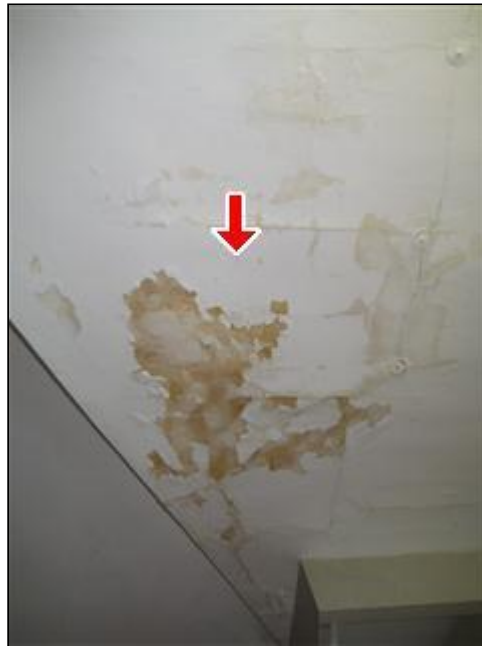
3.1 Picture 2

(2) The plaster on several of the upstairs closet walls shows wet stains indicating moisture or intrusion did or still may occur. The moisture meter was used and it did not indicate an active leak. A qualified contractor should inspect and repair as needed A qualified contractor should inspect and repair as needed.

(2) The plaster on several of the upstairs closet walls shows wet stains indicating moisture or intrusion did or still may occur. The moisture meter was used and it did not indicate an active leak. A qualified contractor should inspect and repair as needed. A qualified contractor should inspect and repair as needed.

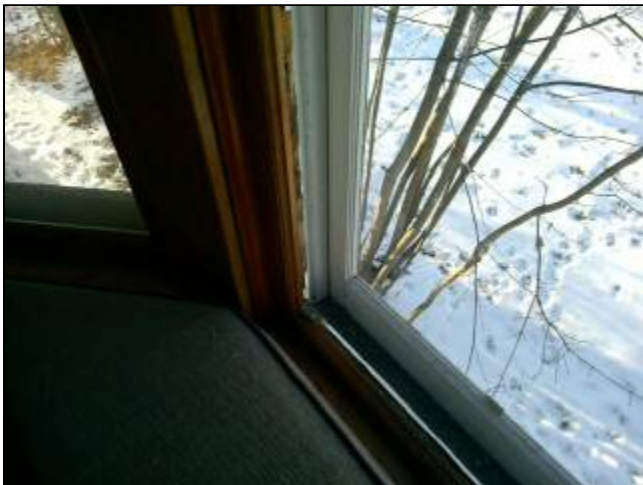
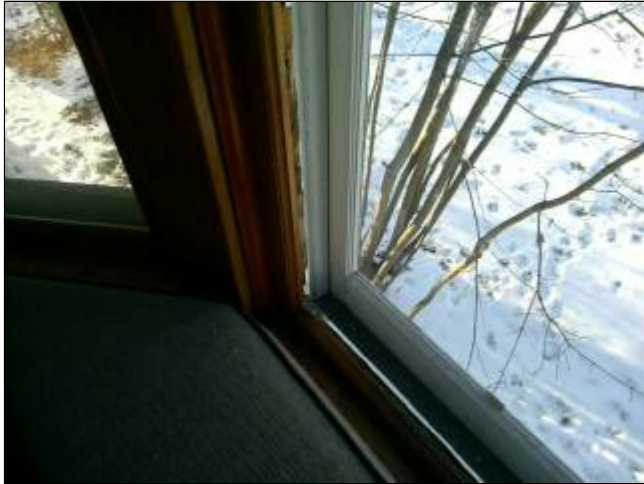
3.6 Picture 1

**3.6** (1) One window pane is completely broken with sharp glass remaining in the frame at a stairway landing window. An occupant could cut themselves on the glass. In addition, this can cause heat loss in winter. A qualified person should repair or replace.

(1) One window pane is completely broken with sharp glass remaining in the frame at a stairway landing window. An occupant could cut themselves on the glass. In addition, this can cause heat loss in winter. A qualified person should repair or replace.

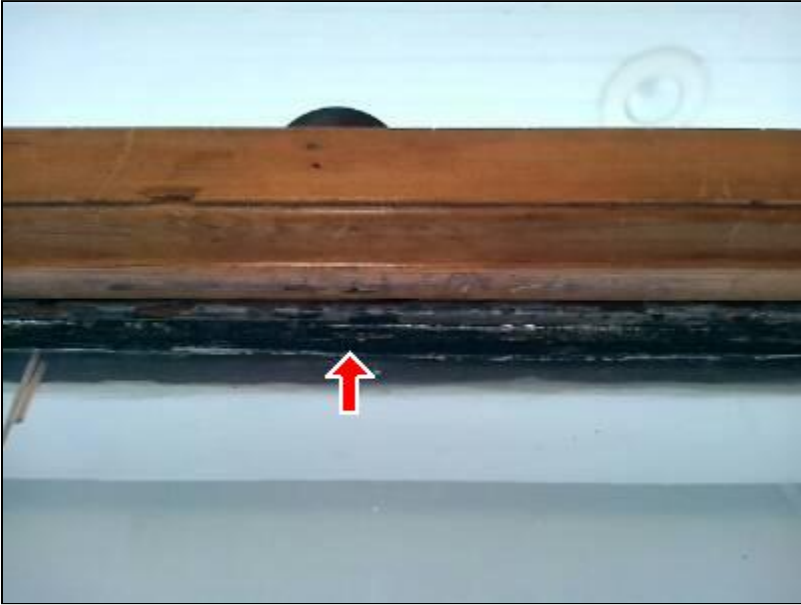
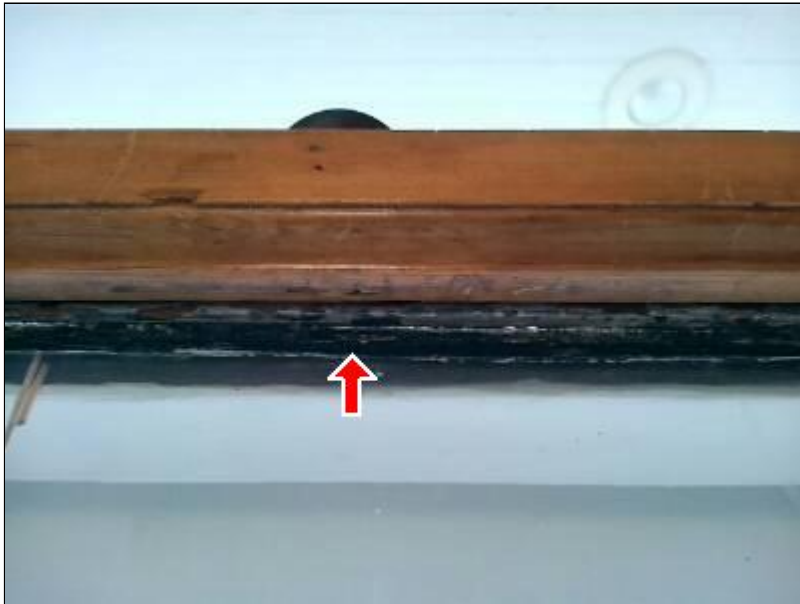
3.6 Picture 2

(2) Window pane has become dislodged from framing and glazing is missing. I recommend repairing for safety and energy efficiency.

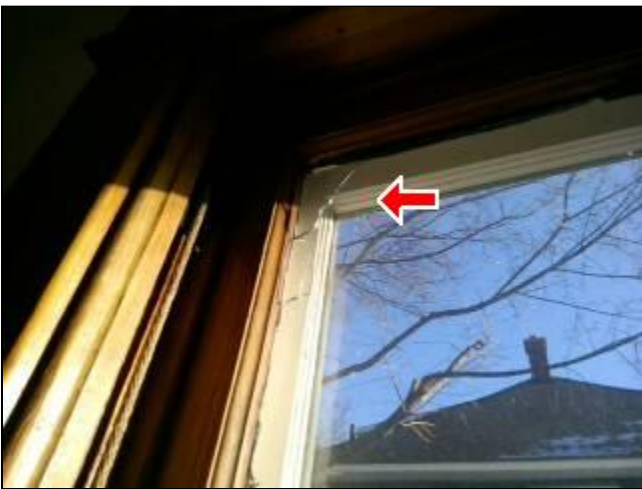
3.6 Picture 3

(3) Cracked window pane on one of the east windows in the living room.

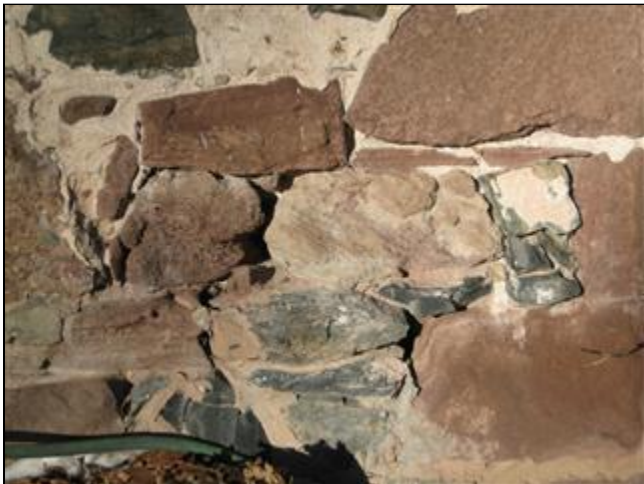
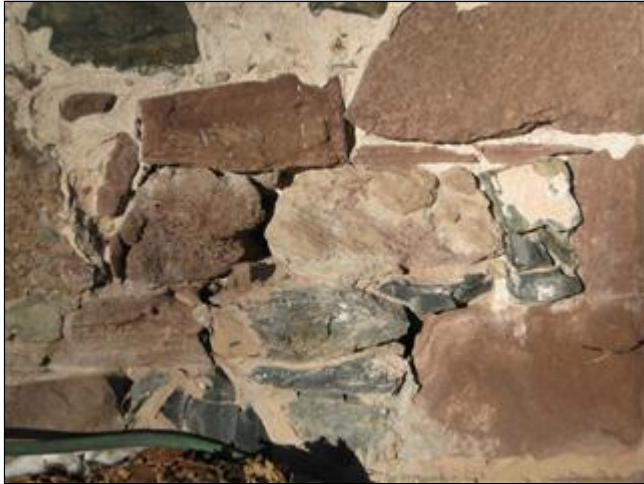
4.0 Picture 1

(2) Multiple crack(s) and spalling in the foundation wall at the (East side of home). The previous repair to wall does not appear adequate. A qualified licensed contractor should inspect further and repair as needed.

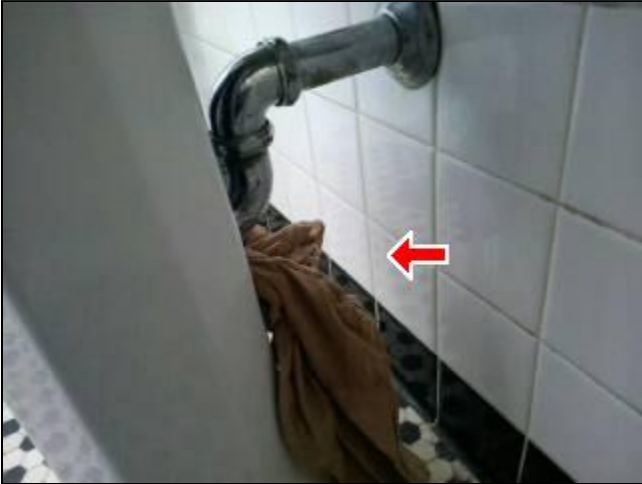
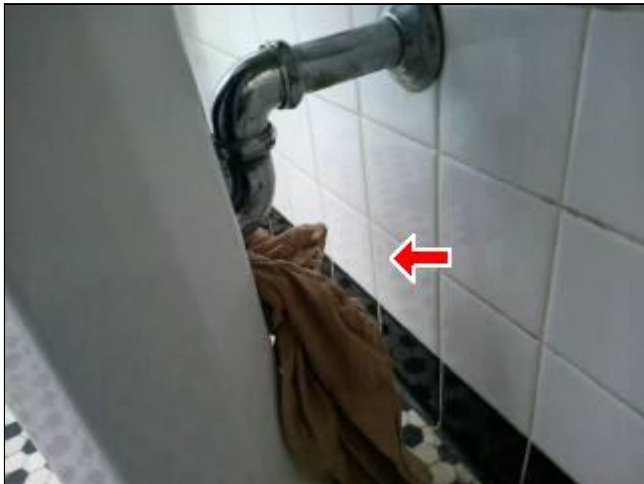
5.0 Picture 1

**5.0** (1) The bathroom sink trap shows signs of previous leaking (shirt stuffed inside sink basin). I performed 3 fill tests and observed no leaking

(1) The bathroom sink trap shows signs of previous leaking (shirt stuffed inside sink basin). I performed 3 fill tests and observed no leaking

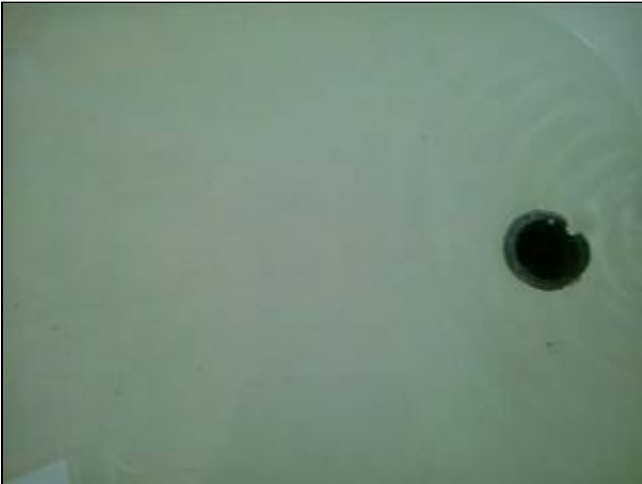
5.0 Picture 2

(2) The bathroom tub is very slow to drain. I recommend cleaning the trap.

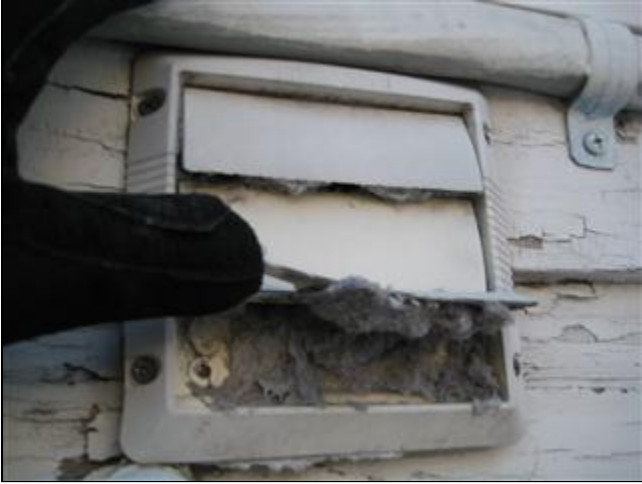
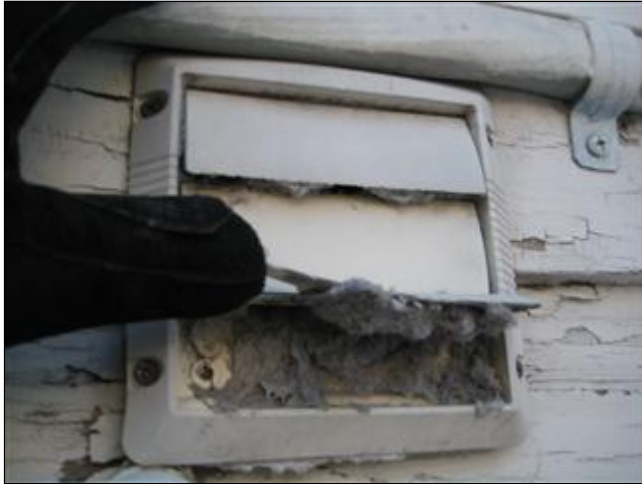
5.0 Picture 3

(3) While a clothes dryer was not present, the dryer venting was choked full of lint. Before installation of a new dryer, the venting should be cleaned to prevent a possible fire or damage to the equipment.

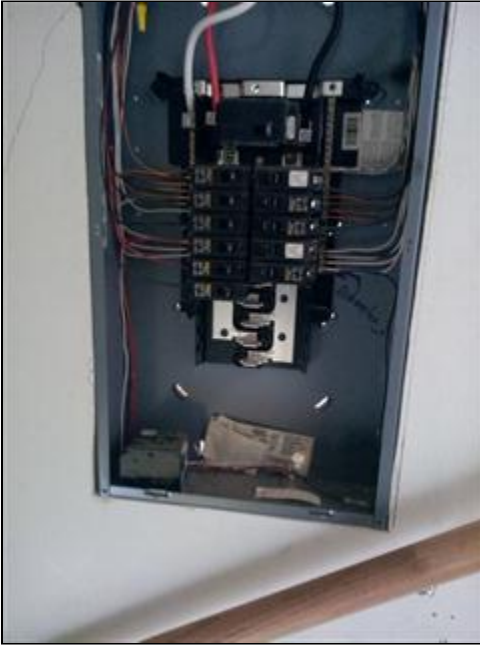
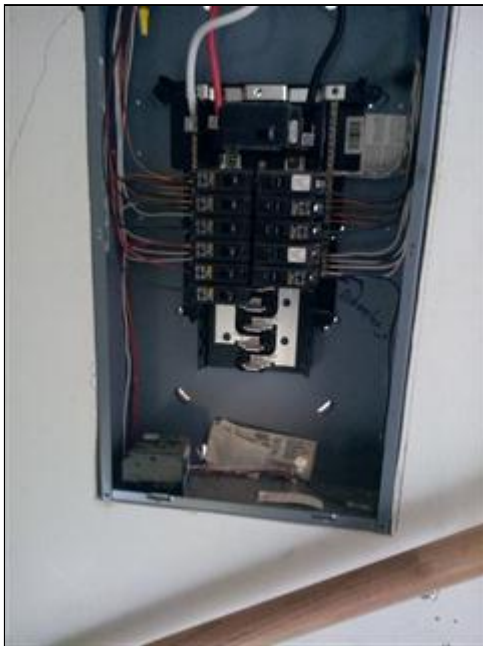
6.1 Picture 1

**6.1** The distribution panel located in the basement stairs is missing its dead front and is situated directly next to stairs railing where some one would reach when going down the stairs. This hazardous condition should be corrected immediately by a qualified electrical contractor.

The distribution panel located in the basement stairs is missing its dead front and is situated directly next to stairs railing where some one would reach when going down the stairs. This hazardous condition should be corrected immediately by a qualified electrical contractor.

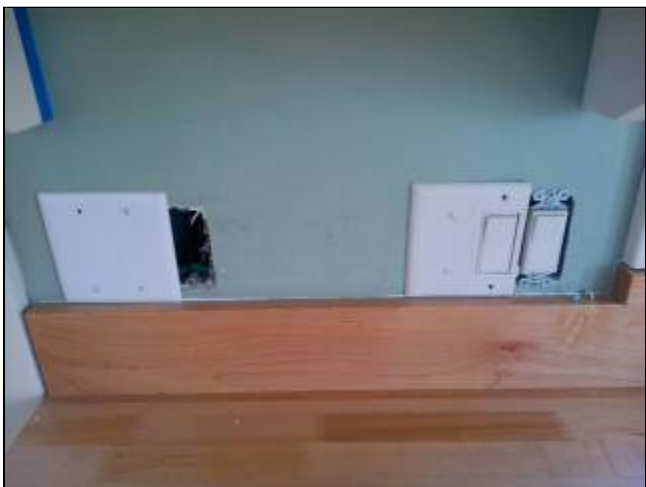
6.3 Picture 1

**6.3** (1) The light fixture is damaged at the Kitchen. This is a safety issue that should be corrected and I recommend repair.

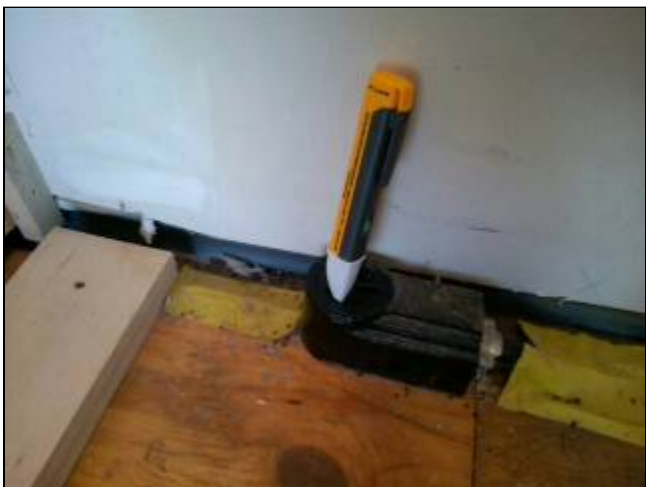
6.3 Picture 2

(2) The "three-prong" outlet is not working in the kitchen. Further inspection is needed by a qualified licensed electrical contractor. I recommend repair as needed.

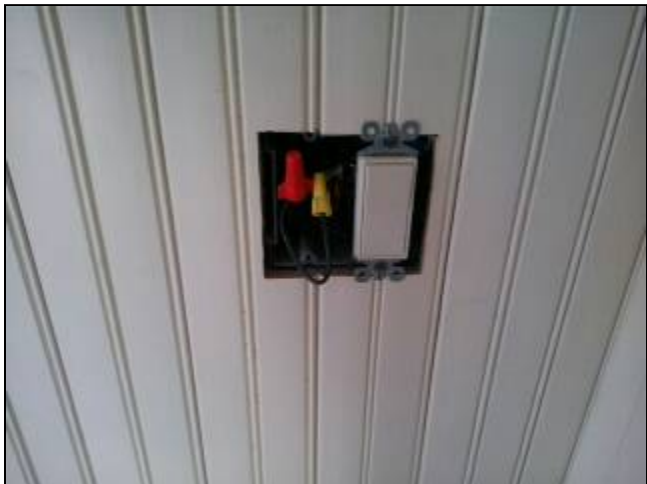
6.3 Picture 3

(3) The wall switch is missing "cover-plate" at the Dining Room. This is a safety issue that needs to be corrected. I recommend repair.

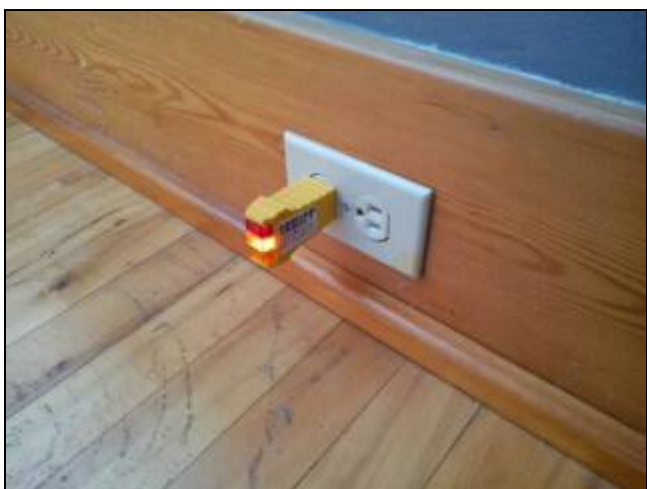
6.3 Picture 4

(4) Receptacles located in the living room and all outlets located on the second story are not grounded properly. I recommend having a licensed electrician repair or replace.

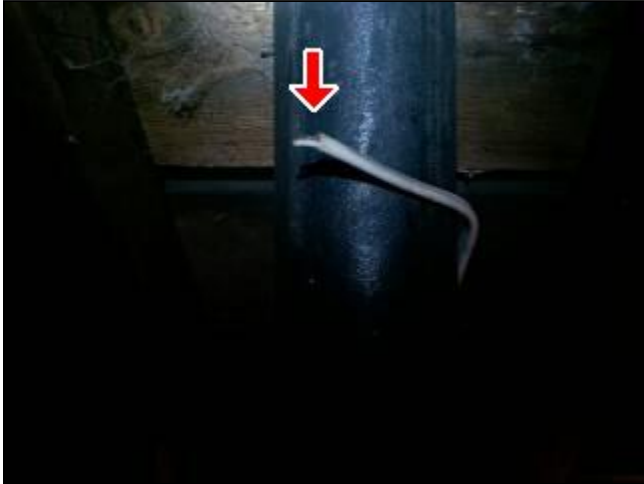
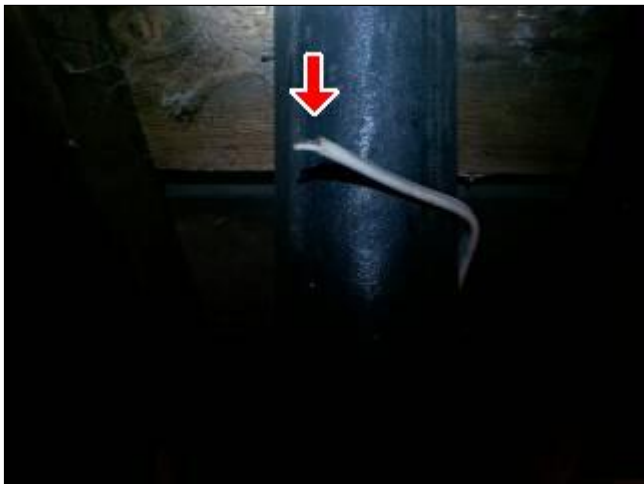
6.3 Picture 5

(5) Energized uncapped Romex wiring was found in attic coiled around the plumbing vent stack. This is a safety hazard and the unused wiring should be removed or capped to prevent electric shock. This should be done by by a qualified electrician.

(5) Energized uncapped Romex wiring was found in attic coiled around the plumbing vent stack. This is a safety hazard and the unused wiring should be removed or capped to prevent electric shock. This should be done by a qualified electrician.

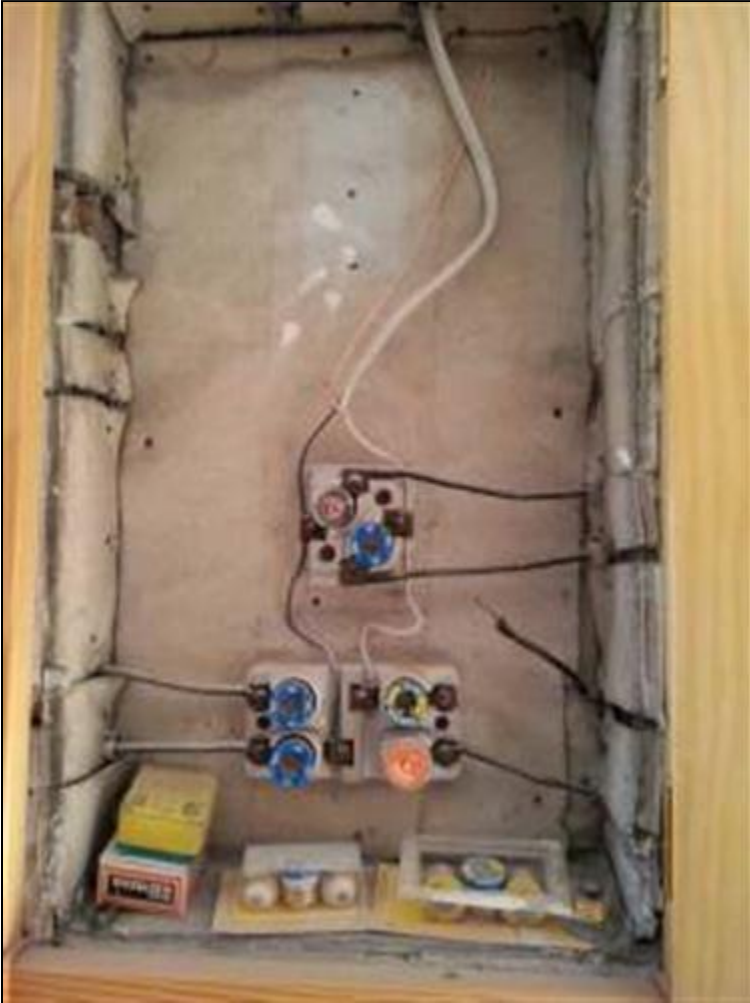
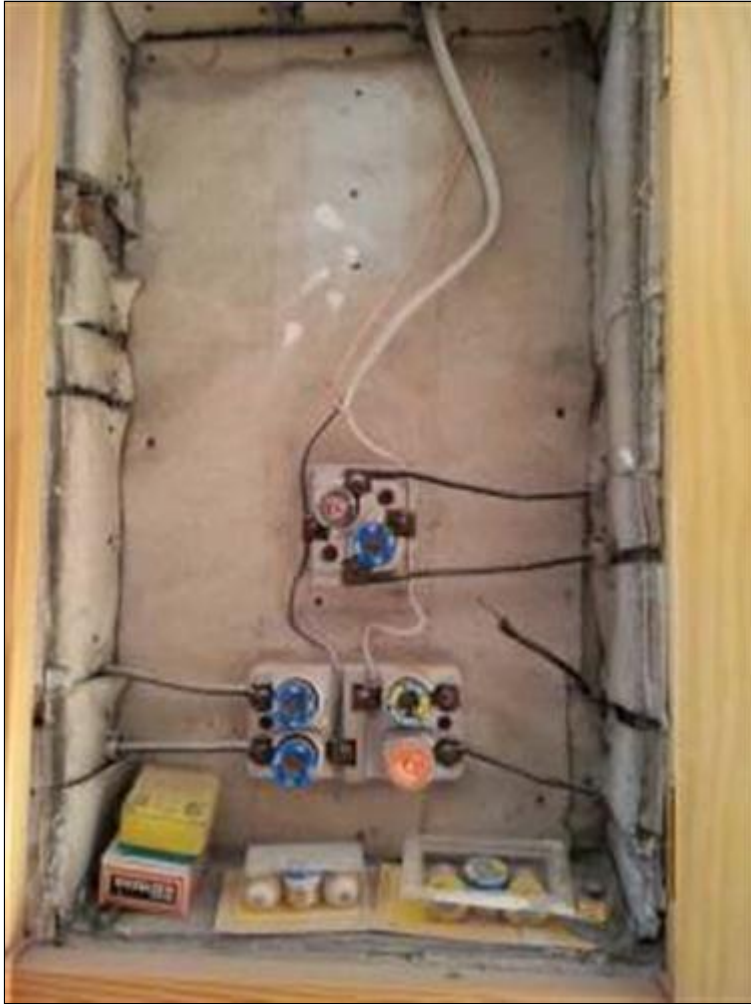
6.6 Picture 1

**6.6** The upstairs distribution panel is not in an approved enclosure. In addition, the panel is not grounded. A qualified electrician should replace and repair.

The upstairs distribution panel is not in an approved enclosure. In addition, the panel is not grounded. A qualified electrician should replace and repair.

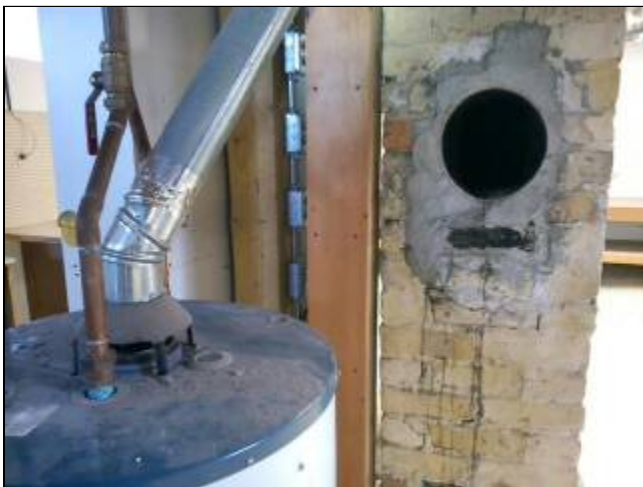
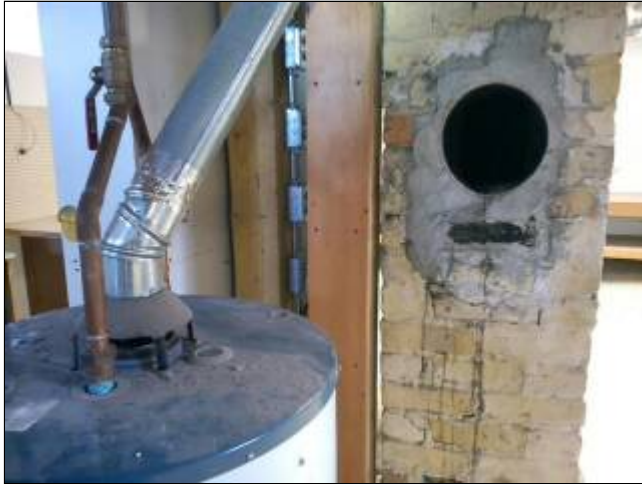
7.5 Picture 1

**7.5** There is an uncovered hole in the chimney flue in the basement. A down draft could cause carbon monoxide to be pushed into the basement. I recommend repairing the hole with a cover.

There is an uncovered hole in the chimney flue in the basement. A down draft could cause carbon monoxide to be pushed into the basement. I recommend repairing the hole with a cover.
